# Marina Visual Inspection Report

July 23 – 24, 2024

Ian Walker, Interior Marine; Travis Rebman, Village of Nakusp

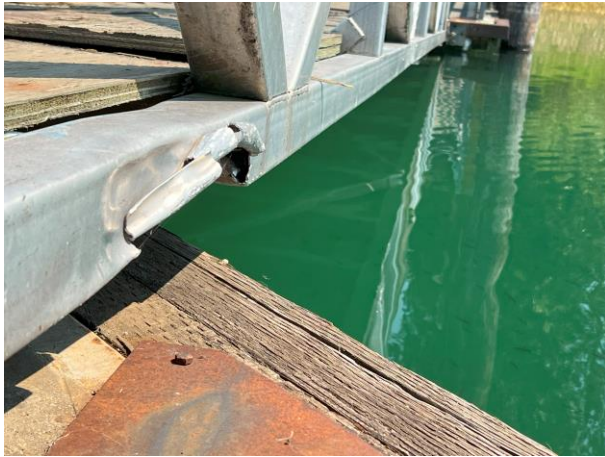
| Item | Condition notes | Follow up |
|---|---|---|
| Last three concrete pontoons before aluminum ramp | Do not float causing aluminum ramp misalignment and damage | Find and repair the holes if possible. May need to be replaced, further investigation required. |

Aluminum ramp from walkway to marina

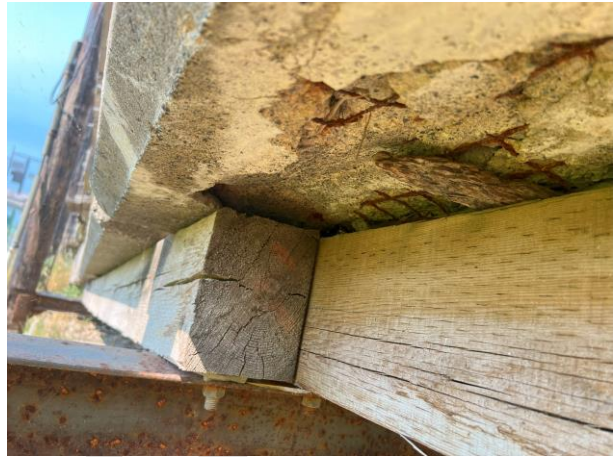
4<sup>th</sup> section of access ramp

| Item | Condition notes | Follow up |
|---|---|---|
| 4 <sup>th</sup> section of access ramp | Damaged concrete | |

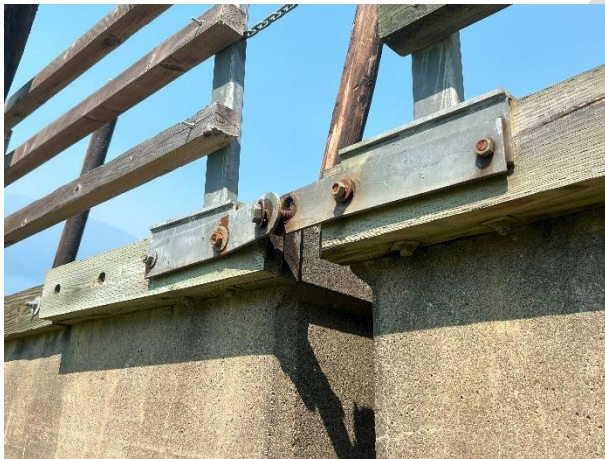
Pivot points between sections of ramps

| Item | Condition notes | Follow up |
|---|---|---|
| Pivot points between sections of concrete ramp | Failing | Possible to get two 3 ton come Along's and pull the sections back together and tighten up the pivot points on each section. Will require new hinges to be fabricated, or new holes cut where old ones oblanged |

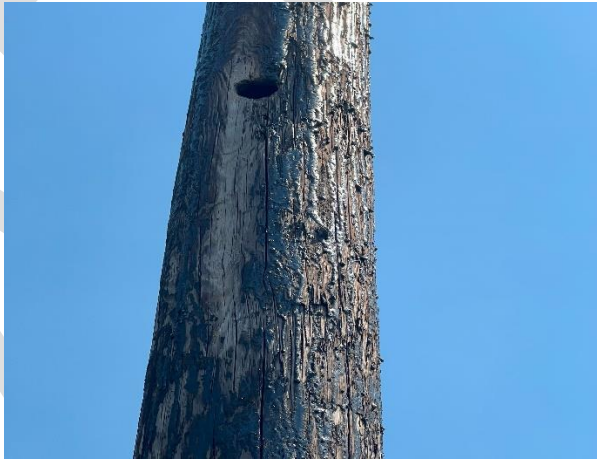
Creosote pile

| Item | Condition notes | Follow up |
|---|---|---|
| Creosote piles | Decent shape but should be replaced with environmentally friendly piles.<br>Some holes in piles from birds nesting, some rot starting in dolphins at beginning of floating walkway | Remove and replace when possible. |

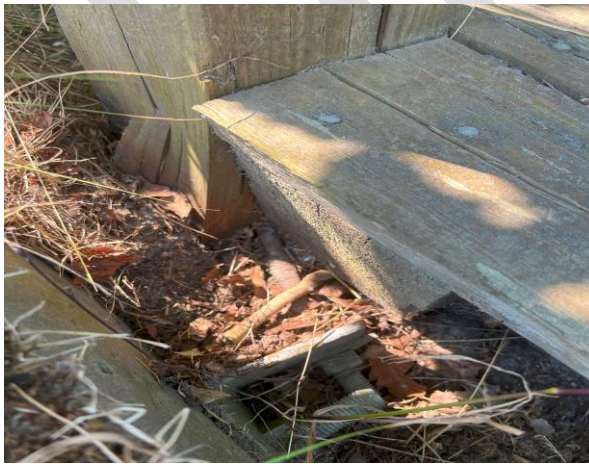
Connection from parking lot to first ramp

| Item | Condition notes | Follow up |
|---|---|---|
| Connection from the parking lot to the first ramp | Pulling apart because ramped dock section pulling on wooden walkway due to improper anchor. | Install a new anchor system and realign the ramped dock. |

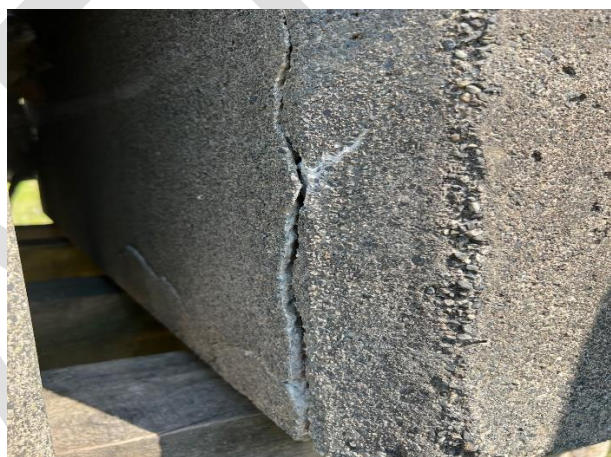
| Item | Condition notes | Follow up |
|---|---|---|
| Fourth piling walking down | Concrete cracking between the sections | |

Concrete cracking between fourth piling

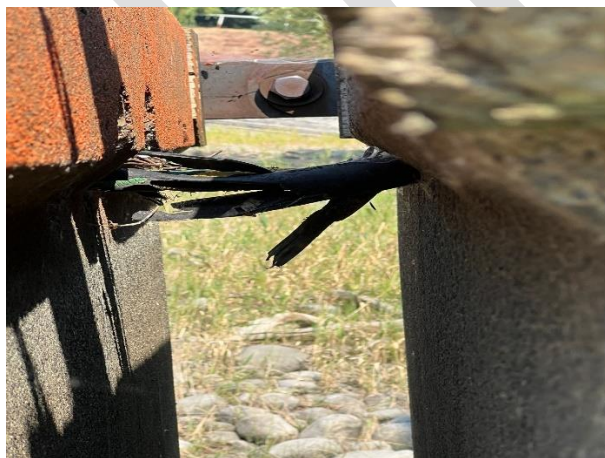
| Item | Condition notes | Follow up |
|---|---|---|
| Electrical lines | Wires are failed | Remove or replace |

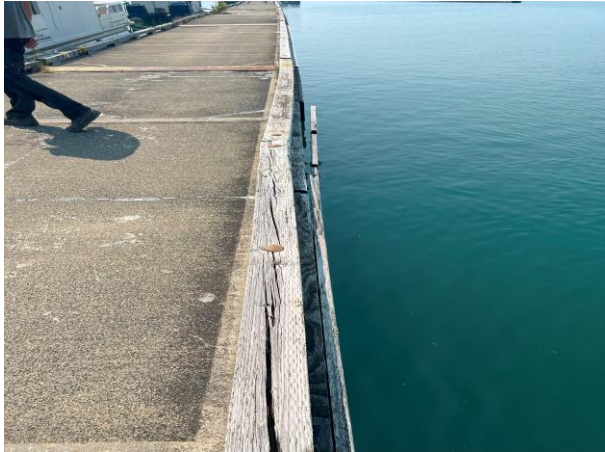
Fascia and Bull Rails

| Item | Condition notes | Follow up |
|---|---|---|
| Fascia boards | Broken sections | Replace |
| Bull rails | Most broken | Replace |

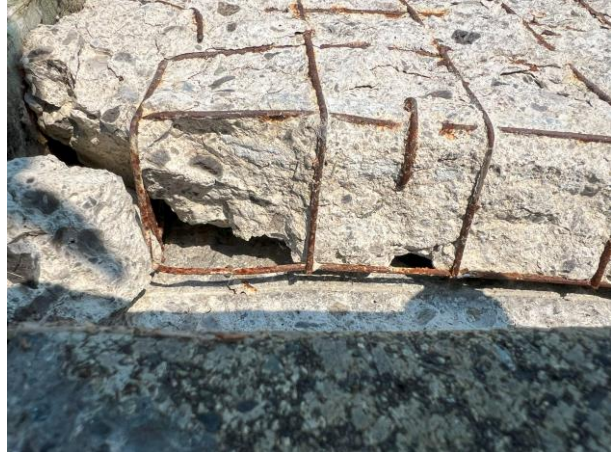
| Item | Condition notes | Follow up |
|---|---|---|
| Concrete attachment of pontoons to fascia | Broken sections, concrete sections starting to shift individually | Needs attention ASAP. Replace broken bolts and replace wood with metal channel |

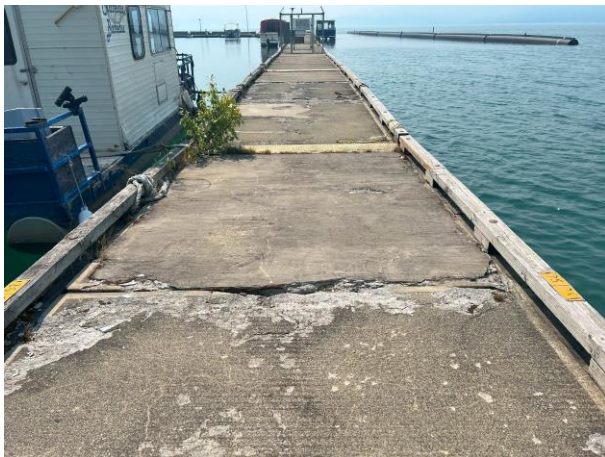
Unevenness along the marina suggests that water is getting in, or uneven weight distribution.

Looking south along marina floating docks,  
Notice the lean and sinking of floats.

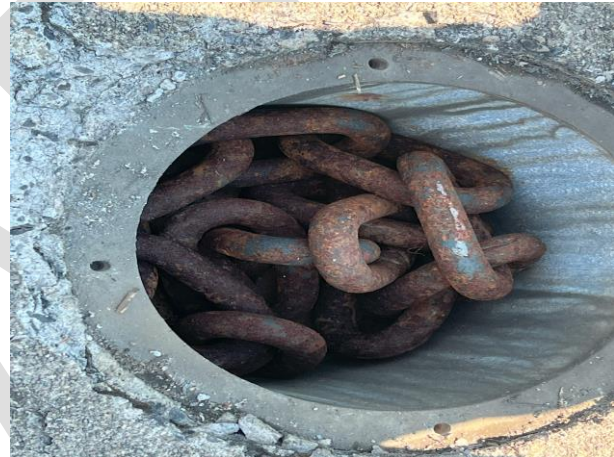
Anchor Chains

| Item | Condition notes | Follow up |
|---|---|---|
| Anchor chains | Visual inspection shows good condition, all shims and locker plates intact | Check anchor layout for any alignment issues |

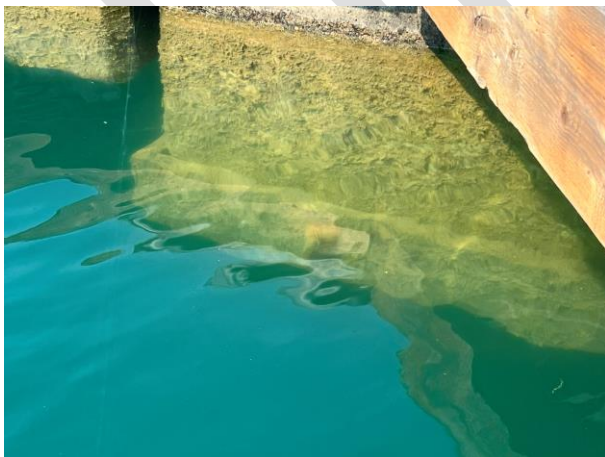
| Item | Condition notes | Follow up |
|---|---|---|
| Southern sections | Exposed foam floats | Repair concrete |

Exposed foam floats on south sections

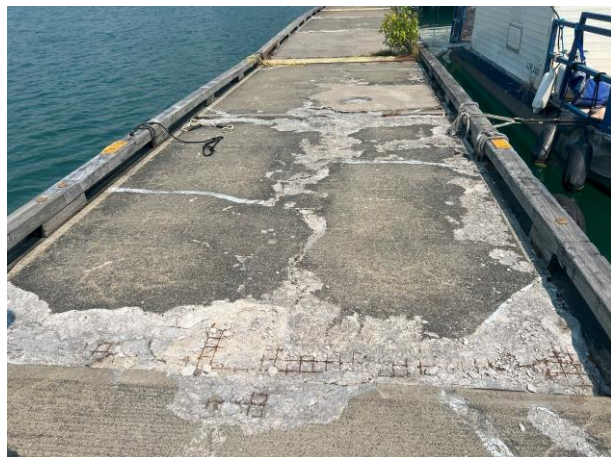
concrete surface on floating docks

| Item | Condition notes | Follow up |
|---|---|---|
| Concrete surface | Some sections of broken concrete | Chip out and repour if no damage to remesh or deterioration of rebar. |

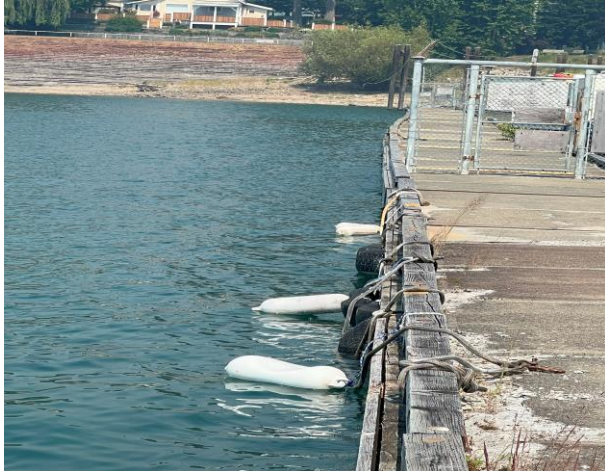
| Item | Condition notes | Follow up |
|---|---|---|
| From the slip 47 to the gate | The walkway bows suggesting the anchors aren't tight enough | Check anchor layout for any alignment issues |

Bend in floating dock walkway

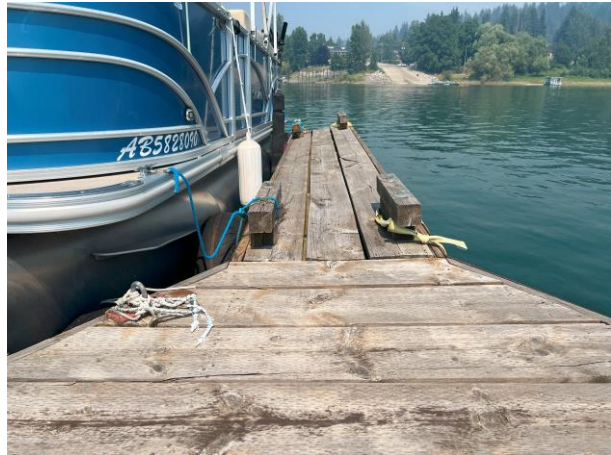
Fingers on south end of marina floating dock

| Item | Condition notes | Follow up |
|---|---|---|
| All fingers on the south end of marina | Poor condition | Replace |

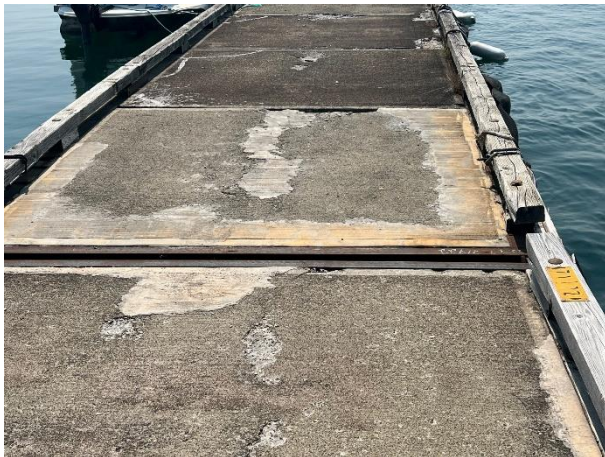
| Item | Condition notes | Follow up |
|---|---|---|
| Slip 71 | Unattached and broken concrete | Priority repair |

Slip 71 unattached and broken concrete

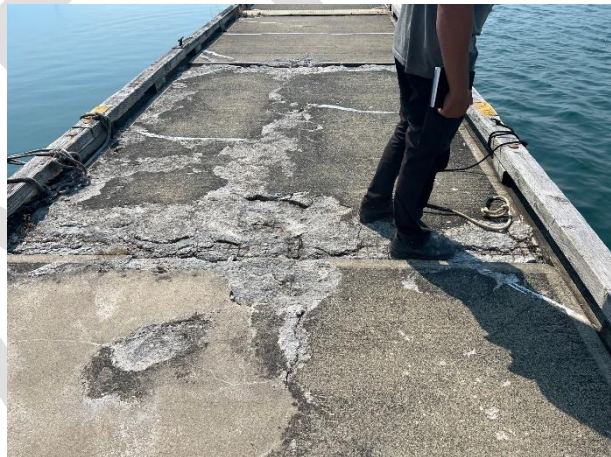
Concrete walkway showing damage

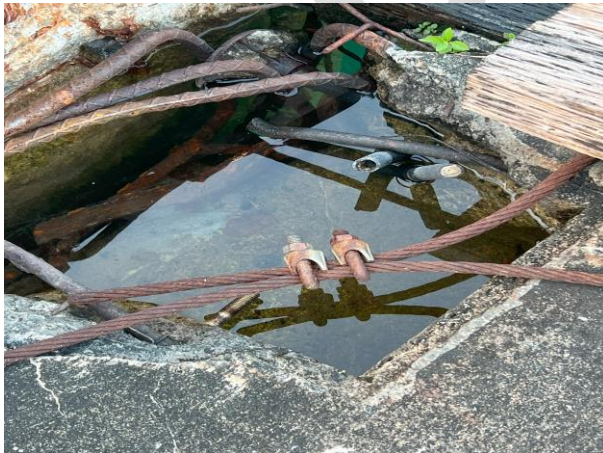
| Item | Condition notes | Follow up |
|---|---|---|
| Post tensioning pockets | Smashed | Replace |

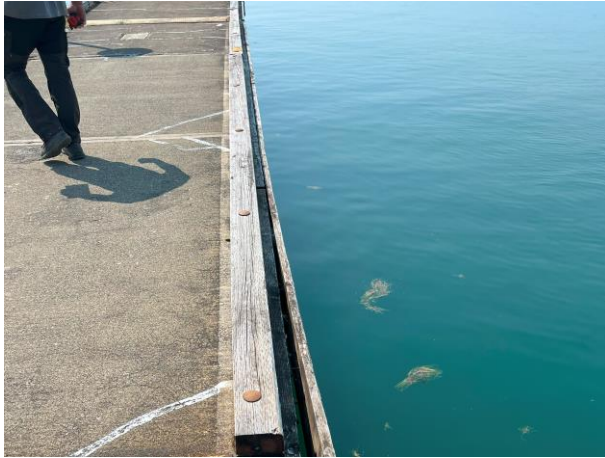
Fascia boards

| Item | Condition notes | Follow up |
|---|---|---|
| Facia boards | Broken | Replace |

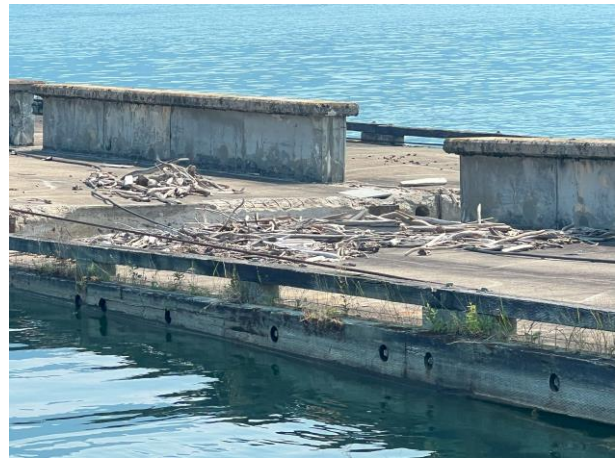
South breakwater mid vertical sections

| Item | Condition notes | Follow up |
|---|---|---|
| Mid vertical sections | Poor concrete condition | Repair or remove |

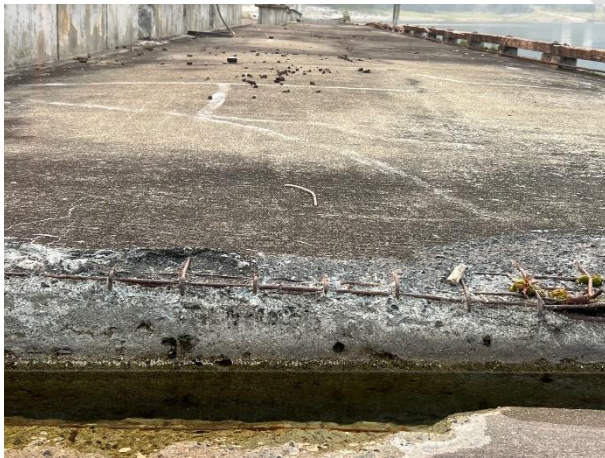
| Item | Condition notes | Follow up |
|---|---|---|
| Breakwater section 2 | Water or air pressure causing heaving | Pump out and check for holes |

South breakwater heaving

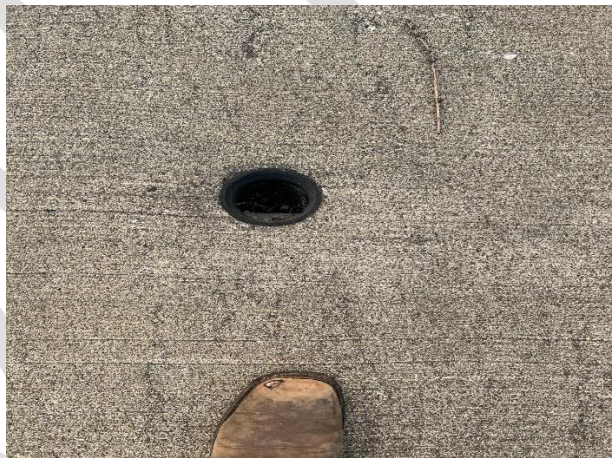
| Item | Condition notes | Follow up |
|---|---|---|
| Access hole plugs | Missing | Replace |

Missing access hole plugs

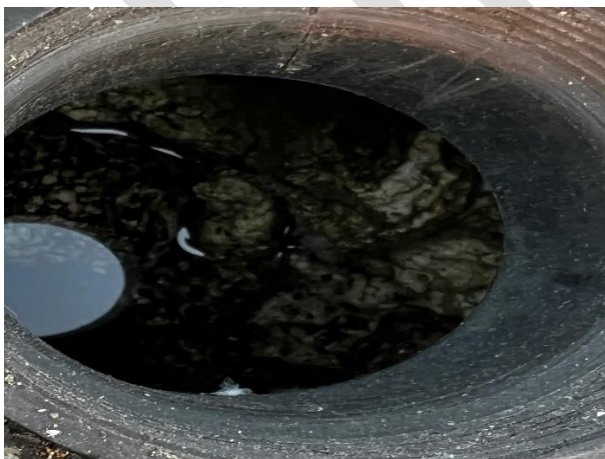
Access hole filled with water
