# Marina Visual Inspection Report

July 23 – 24, 2024

Ian Walker, Interior Marine; Travis Rebman, Village of Nakusp

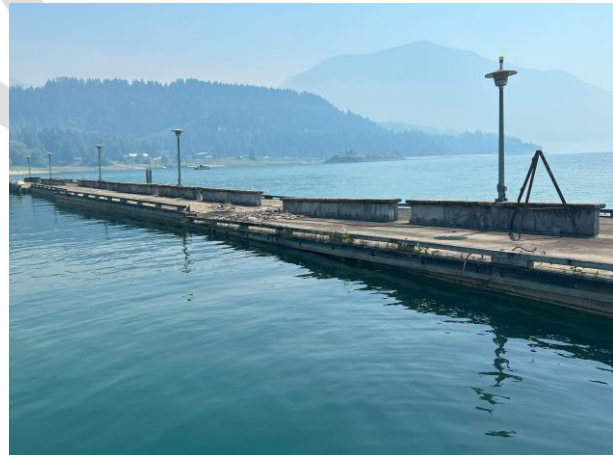
South breakwater

It is in poor condition with multiple sections listing due to systemic failures, and the overall integrity at risk because of broken attachment points.
